Inspection Report

Property Address

123 Your Street
Hometown NC 28000

Patriot Home Inspections Inc.

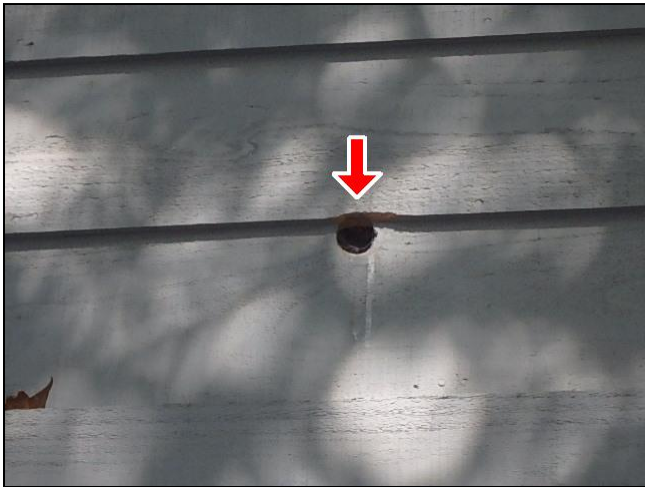
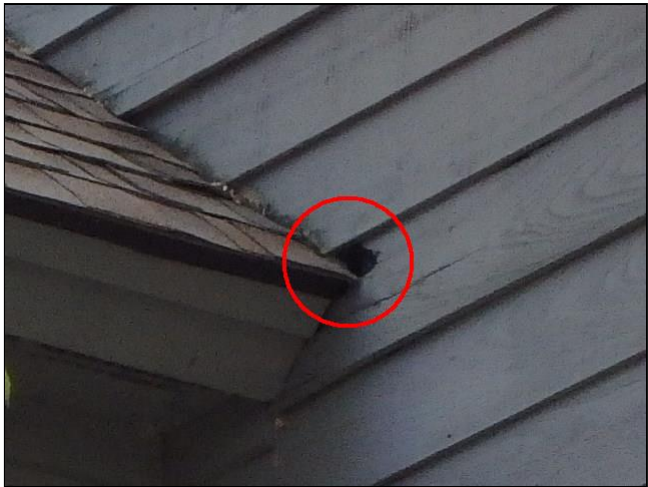
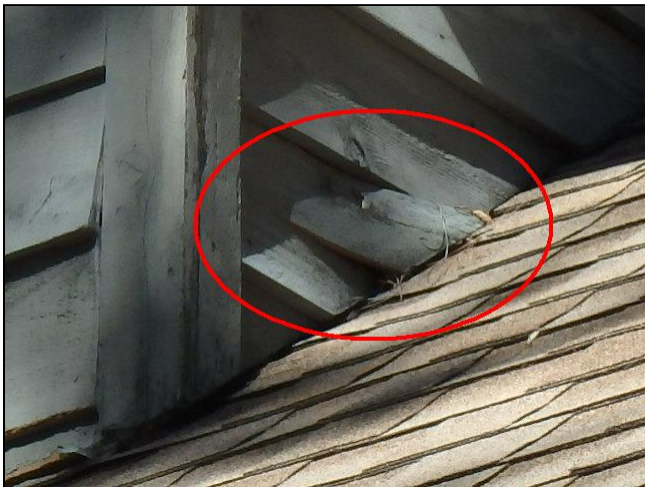
2.0 (1) There were one or more large holes in the siding at the front left side of home and a damaged piece of siding along the roofline at the front right side of home. These conditions can result in water penetration behind the siding, resulting in damage to the underlying components. Recommend that a qualified contractor repair as needed.

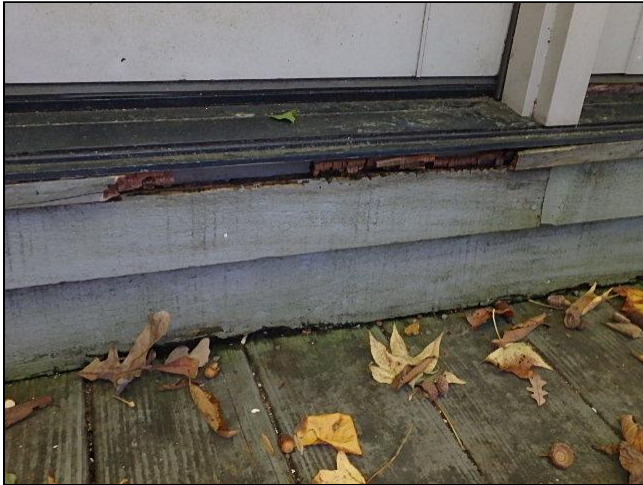
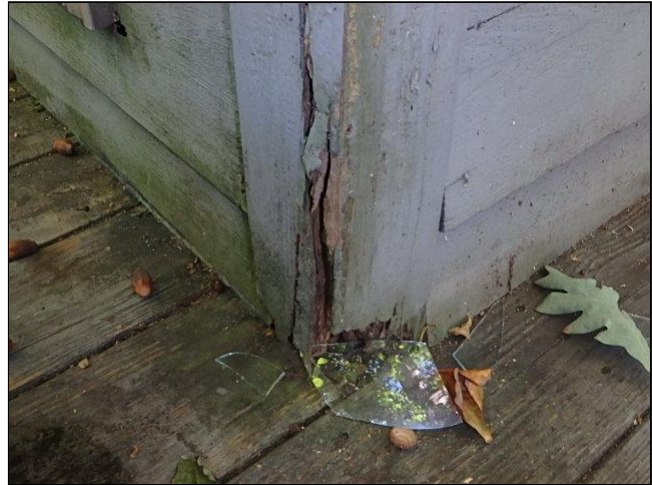
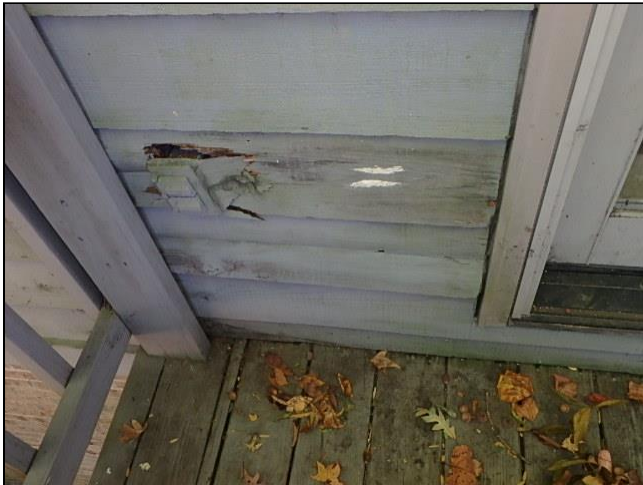
2.0 (2) Moisture damage/decay was found in the siding and trim at or around the rear entry door. Because of the extent of deterioration it is possible for some framing to be deteriorated. Recommend that a qualified contractor evaluate and repair as needed.

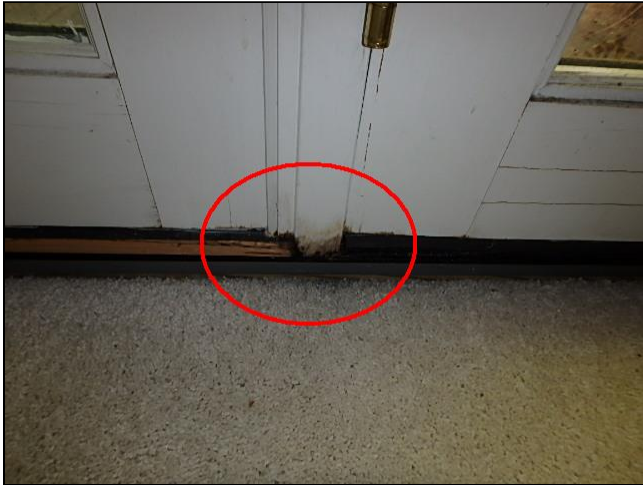
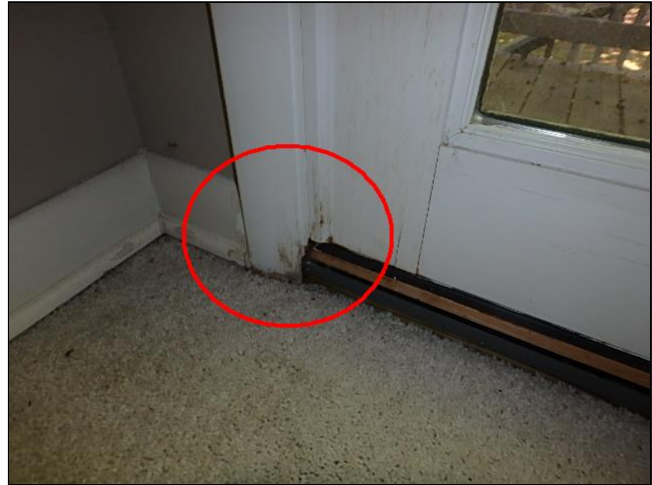
2.1 (3) The interior of the rear entry door revealed water stains indicating leaks did or still exist. Due to the lack of heavy rainfall, I am unable to determine if the leaks still exist. Recommend asking the property owner about this, monitoring the stains in the future, and/or having a qualified contractor evaluate and repair if necessary.

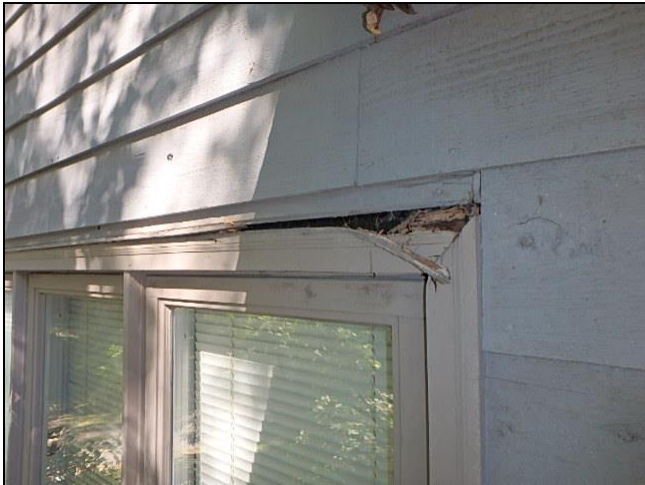
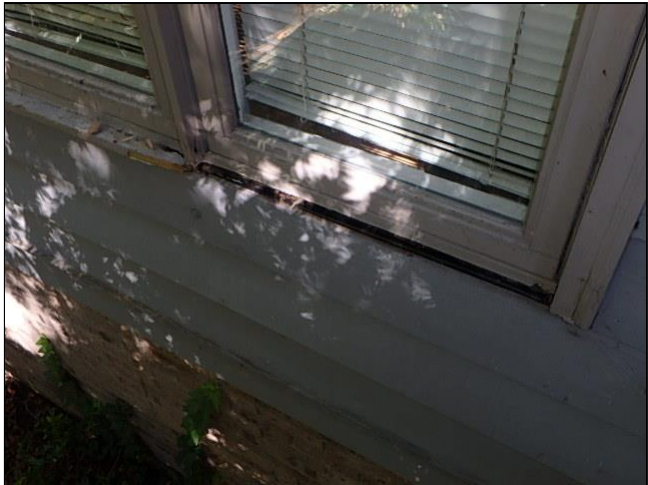
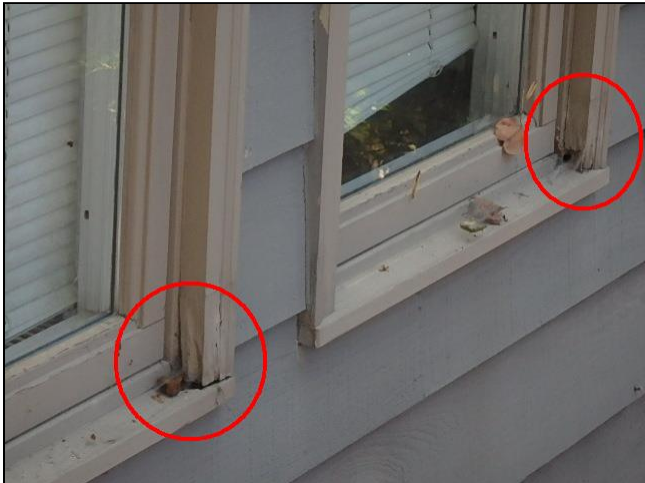
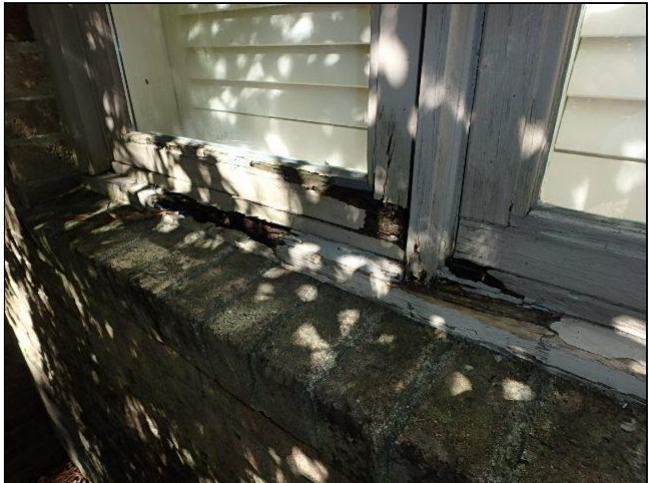
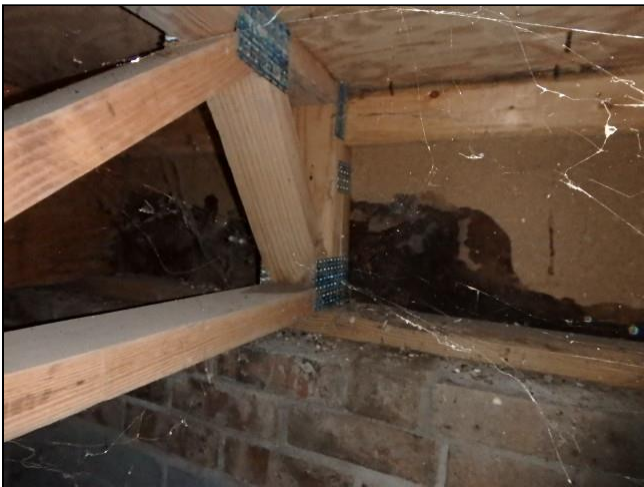
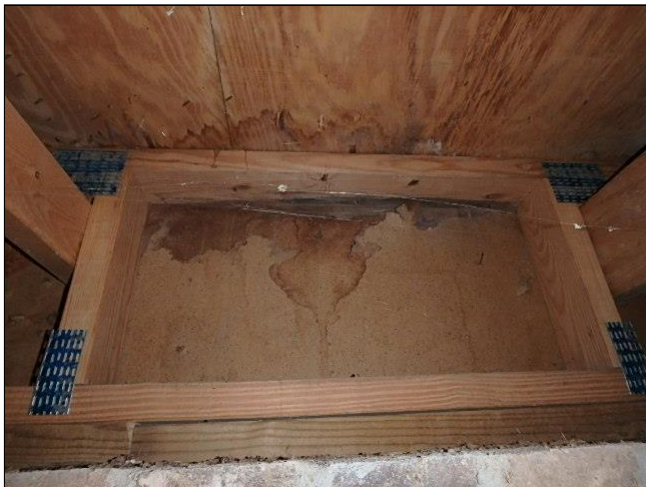
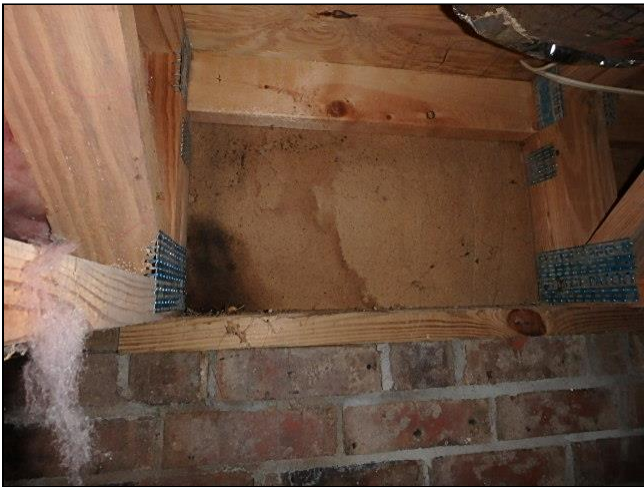
2.2 Moisture damage/decay was found in the wood sills and trim at one or more windows around the home. The wall and floor sheathing in the crawlspace under the master bedroom and dining room areas revealed water stains indicating that water is entering the wall structure. Because of the extent of deterioration and water penetration it is possible for some framing to be deteriorated. Recommend that a qualified contractor evaluate and repair as needed.

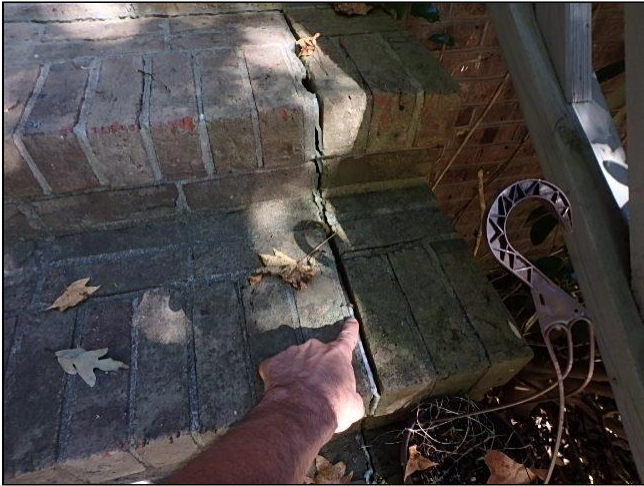
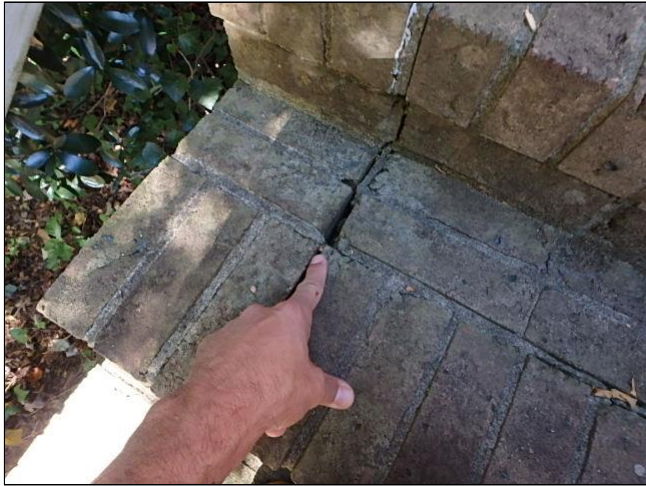
2.3 (1) The brick steps at the front of home have separated and settled at one or more of the mortar joint. Water can enter the structure and cause further deterioration due to freeze-thaw cycles. Recommend that a qualified contractor repair as needed.

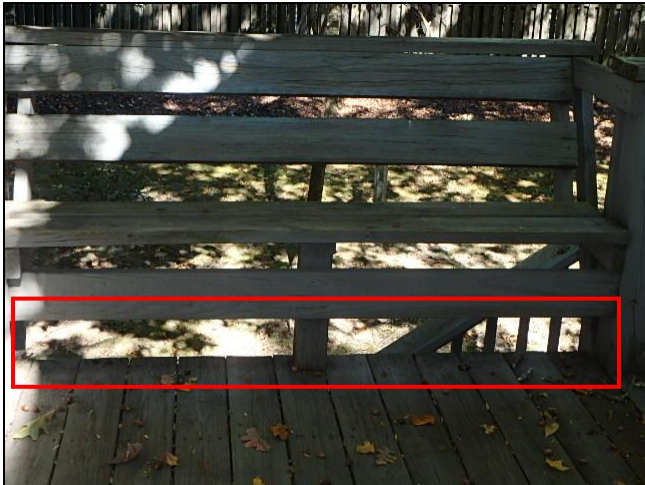
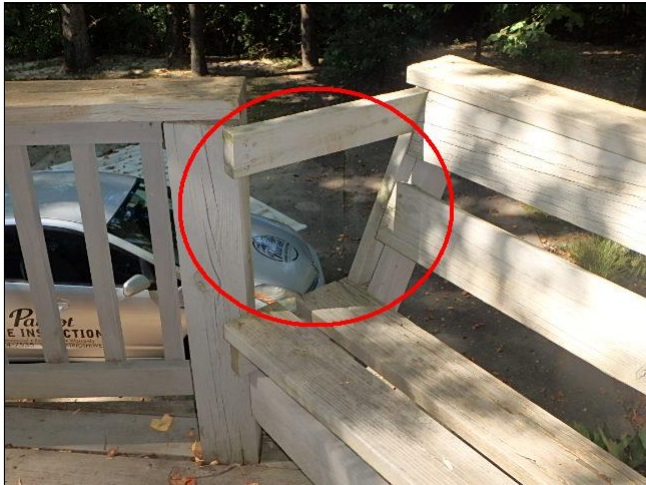
2.3 (2) Perimeter bench seating was installed at the deck where walking surfaces were more than 30 inches above the surrounding grade. Bench seating is not a safe substitute for standard guardrails, and is a potential fall hazard. Gaps in such seating often allow small children to climb underneath and fall. People sitting or standing on benches may also fall. The clients should at least be aware of this hazard, especially if small children are present. Recommend having a qualified contractor repair as necessary to eliminate fall hazards around bench seating.

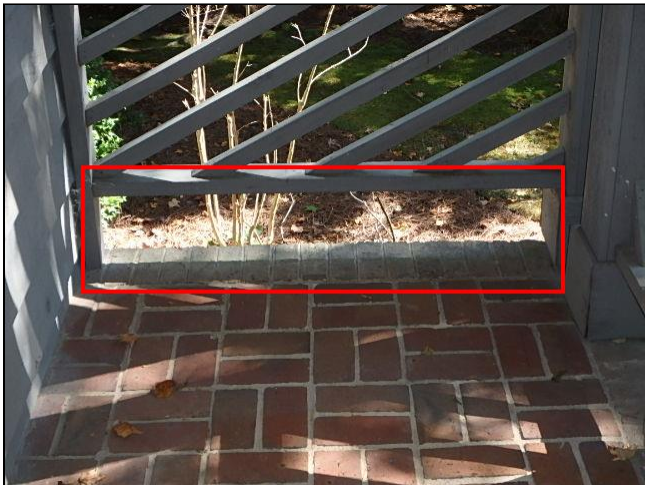
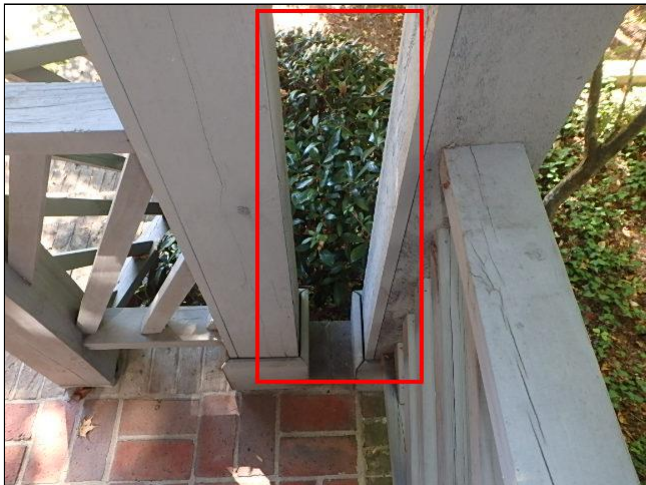
2.3 (3) Guardrails at the front entry stoop where drop-offs were higher than 30 inches had gaps that were too large. This poses a safety hazard for children (e.g. falling, getting stuck in railing). Safe building practices dictate that guardrails should not have gaps or voids that allow passage of a sphere equal to or greater than 4 inches in diameter. Recommend that a qualified contractor repair guardrails per standard building practices.

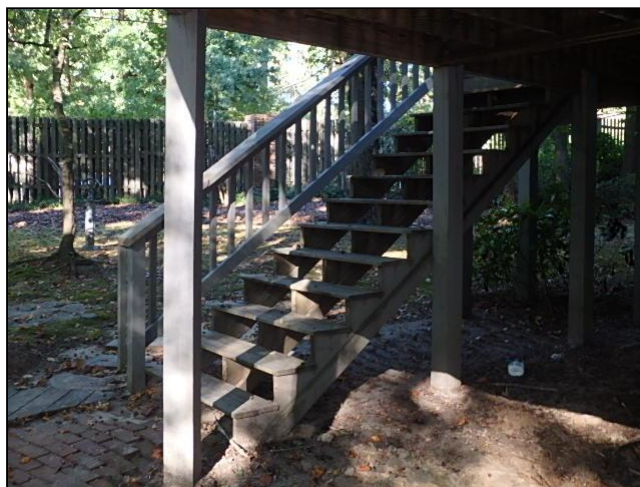
2.3 Picture 7

2.3 (4) The stairway for the deck is open or not guarded by a rail to prevent possible falls along the high side adjacent to the deck body. Recommend that a qualified contractor be consulted to make necessary repairs to ensure safe access and egress.

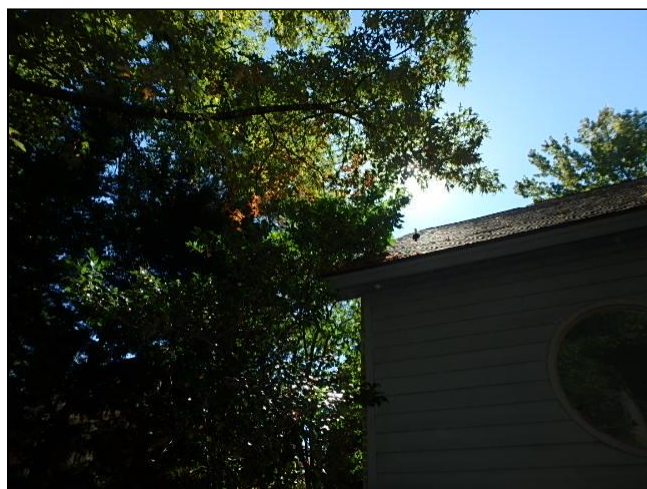
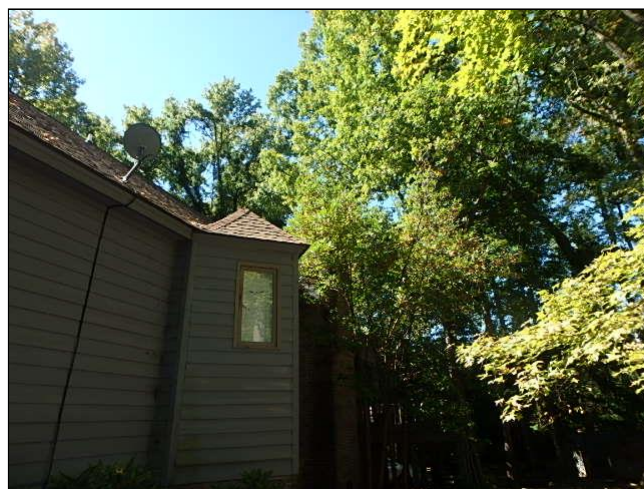
2.4 (2) Note: Trees were in contact with or were close to the building at one or more locations. Damage to the building can occur, especially during high winds. It is recommended that you have a qualified tree service contractor or person trim back the trees as necessary.

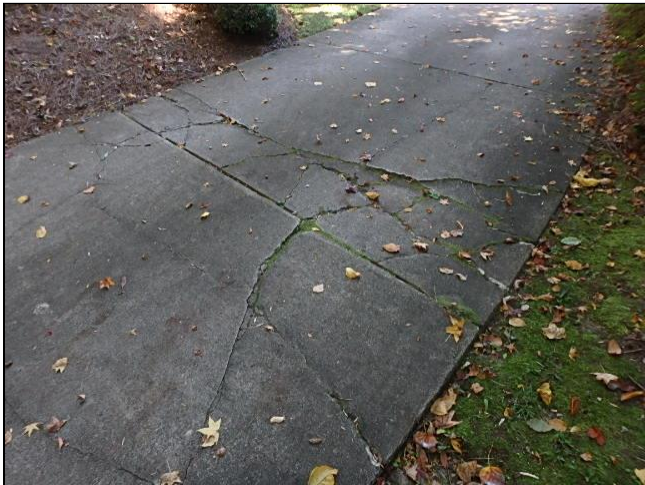
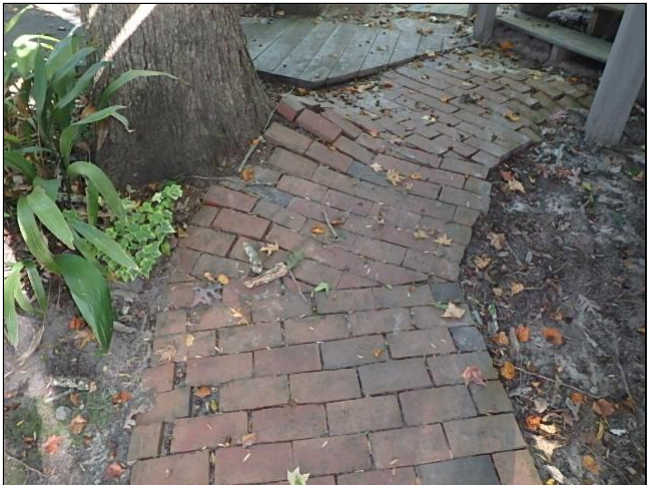
2.4 (3) Cracks, settlement and heaving resulting in trip hazards were found in the concrete driveway and brick walkway. For safety reasons, recommend that a qualified contractor repair as needed.

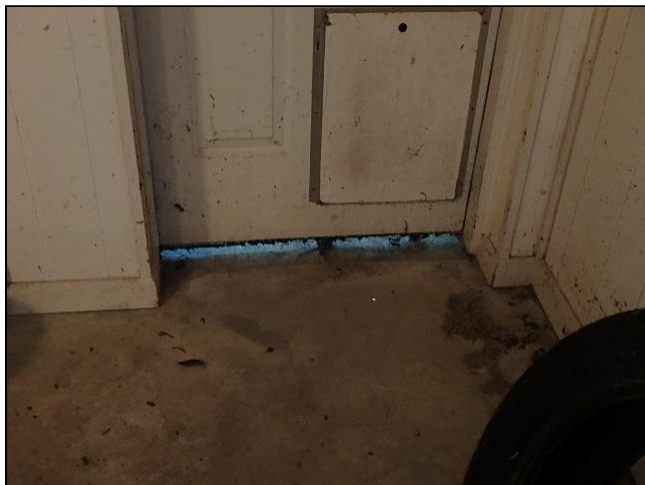
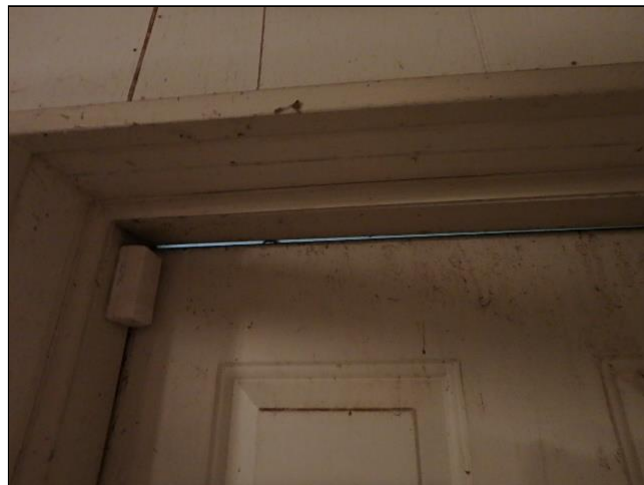
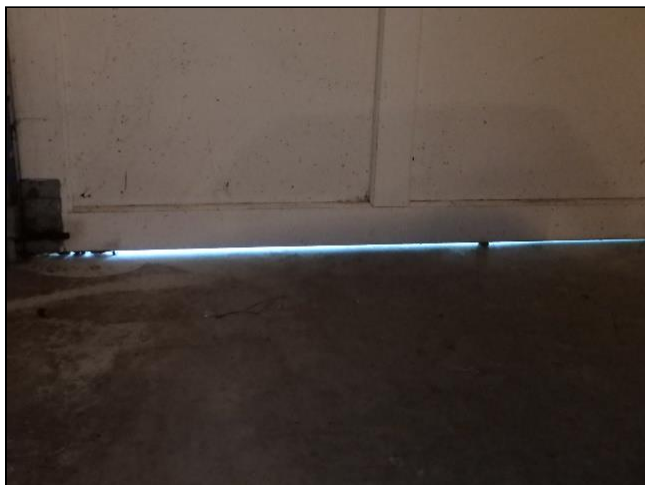
3.3 (1) The garage vehicle and pedestrian doors were not sealing or closing tight at there openings and/or floor (daylight revealed). Vermin and insects can enter the garage as a result. Recommend that a qualified contractor or person repair as needed.

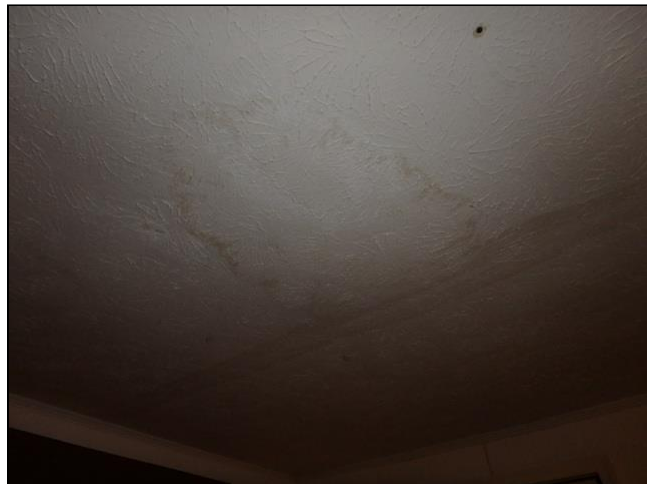
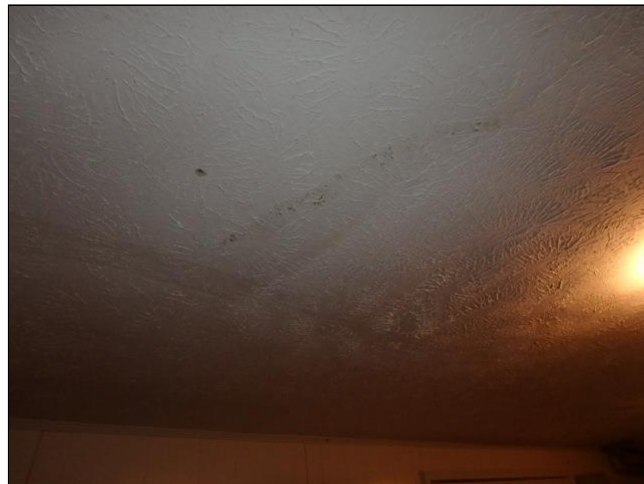
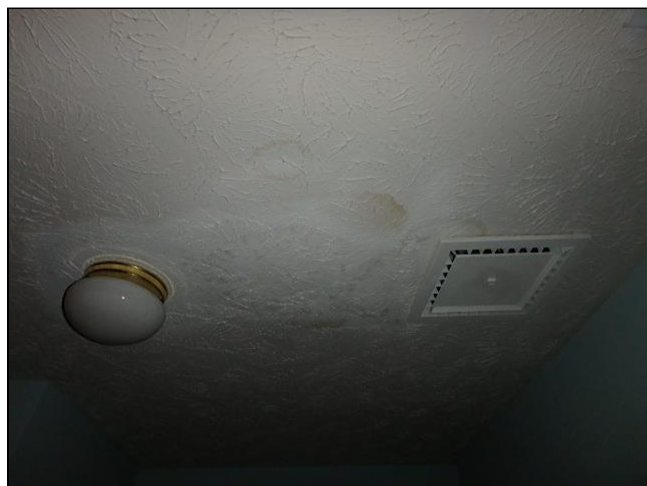
4.0 The sheetrock on the garage and upstairs master bath ceilings revealed water stains indicating leaks did or still exist. Due to lack of heavy rainfall and the house not being lived in for an extended period of time, I am unable to determine if the leaks still exist. Recommend asking the property owner about this, monitoring the stains in the future, and/or having a qualified contractor evaluate and repair if necessary.

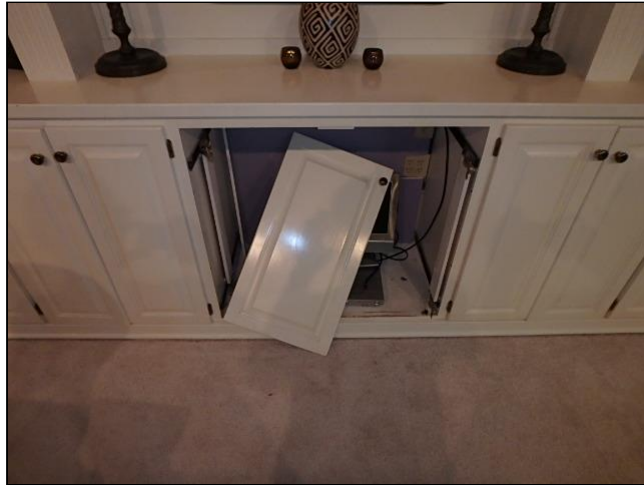
4.4 Picture 1

4.4 The cabinet doors were missing and/or removed from the hinge hardware at the family room entertainment center. Recommend that a qualified person repair or correct as needed.

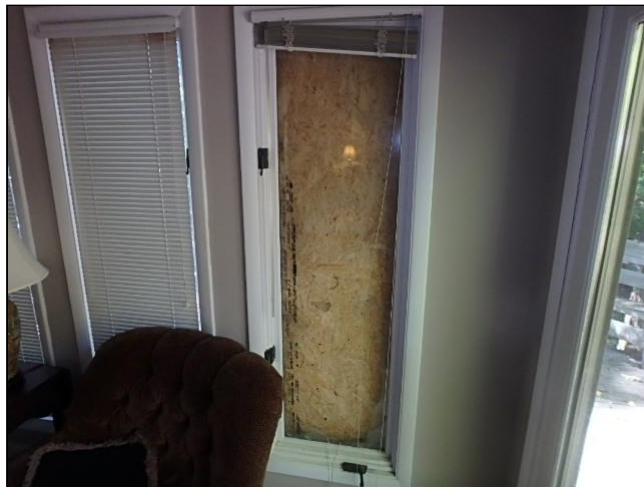
4.6 Picture 1

4.6 (1) One of the window panes was damaged in the family room. Damaged glass should be replaced to prevent injury. Recommend that a qualified contractor perform the work involved.

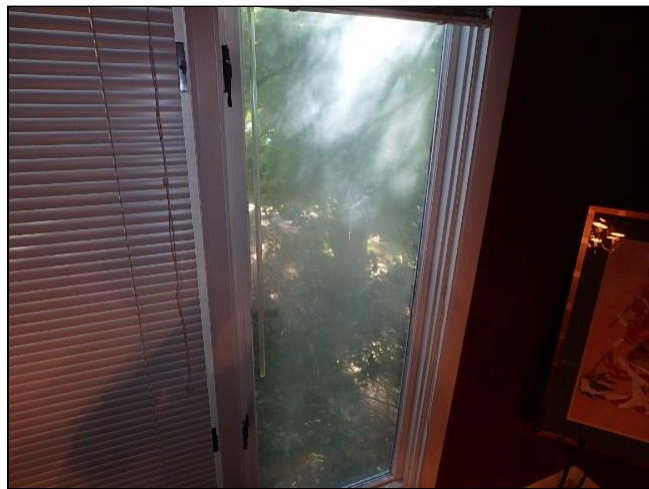
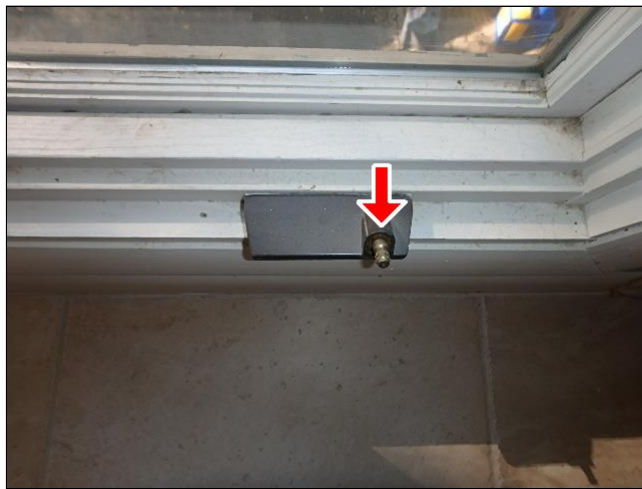
4.6 (3) The following defects were noted at one or more of the windows throughout the home. Windows were painted or stuck shut (inoperable), had crank hardware that was missing parts or did not function when tested and/or had failed seals between multi-pane glass based on condensation or stains between the panes. Recommend that a qualified contractor evaluate and repair as needed.

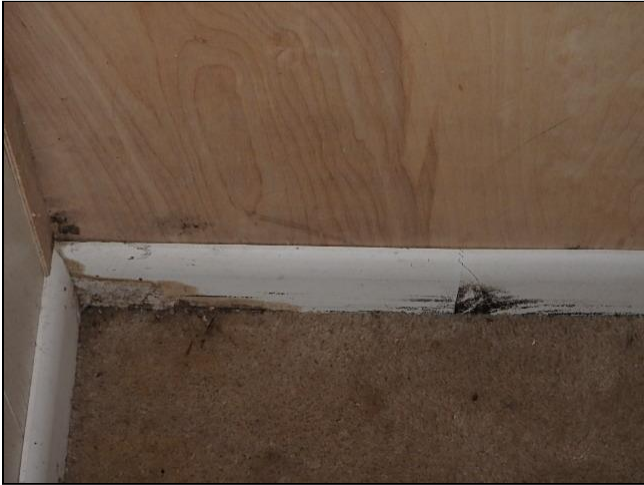
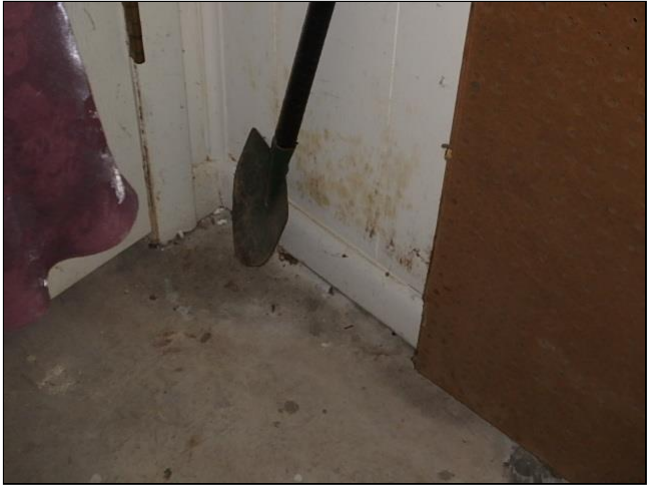
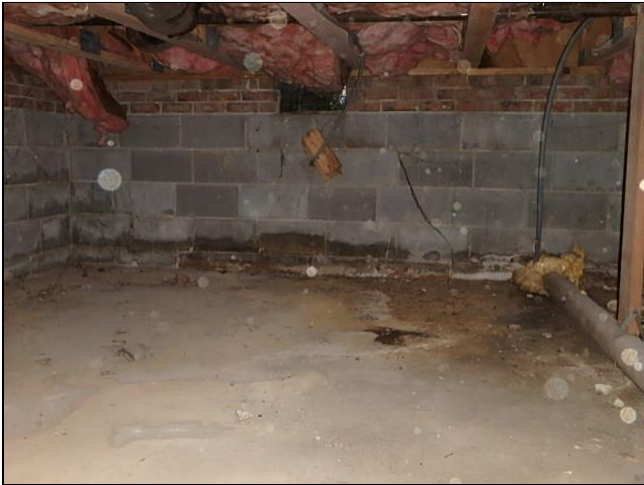
5.0 Although the grading around the home appeared to be acceptable, there was evidence of water intrusion based on moisture stains observed on the foundation walls and concrete slab in the crawlspace and garage. Water intrusion can affect the foundation of the home or cause deterioration and excessive moisture on building components over the life of the home if not corrected. Recommend asking the property owner about this, monitoring the stains in the future, and/or having a qualified contractor evaluate and repair if necessary.

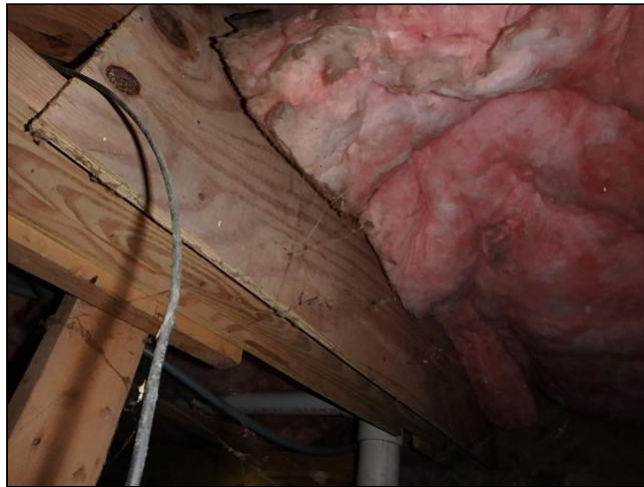
5.3 Picture 1

5.3 A previous repair was observed at one of the floor trusses under the master bath area. Any repairs should be supported by an engineering letter for documentation. Recommend asking the seller about this and/or consulting an engineer to review the truss repair and ensure repair specifications were satisfied.

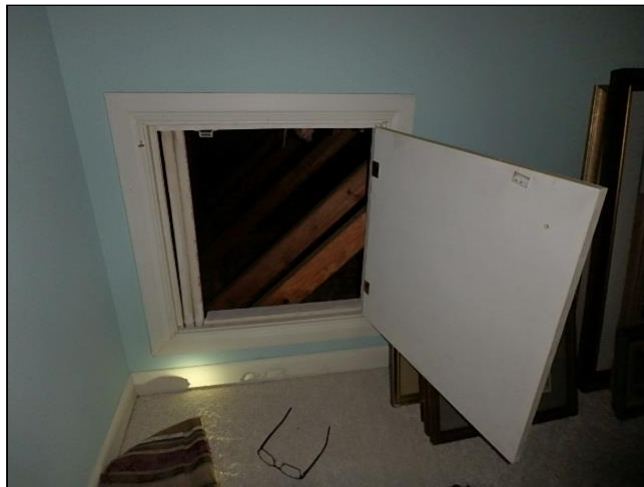
5.5 Picture 1

5.5 (2) The attic access door was not insulated. This will cause unnecessary heat loss in winter and heat gain in summer, and increase energy costs for the property. Recommend installing insulation as necessary and per current standards for better energy efficiency.

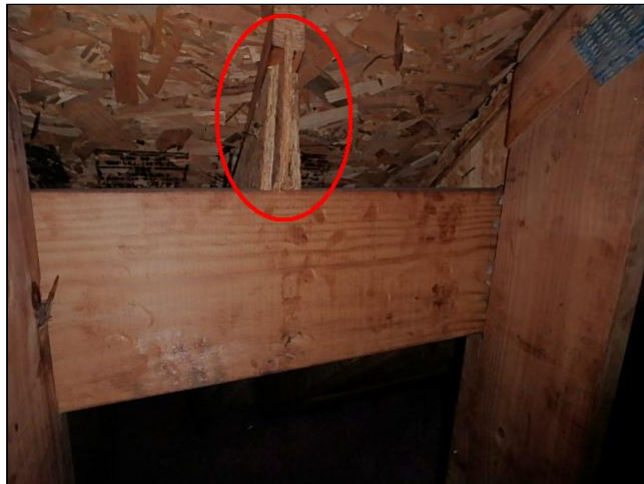
5.5 Picture 2

5.5 (3) The roof framing located in the attic over the family room was supported by a wood header supported by a bearing point created by a notch in the main roof truss post. The connection points show evidence of possible compression or movement. Recommend that the header support and joist installation be evaluate and repaired if deemed necessary by a qualified contractor to ensure the stability of the roof system.

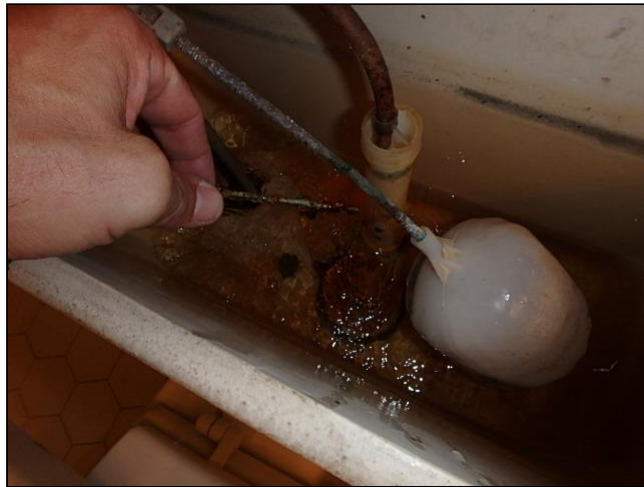
6.0 Picture 1

6.0 (3) The toilet in the upstairs master bath (on right) ran water continuously and the flush valve linkage was corroded to the point where it became disconnected from the flush valve (unable to flush toilet). Significant amounts of water can be lost through such leaks. Recommend that a qualified plumber or person repair or replace components as needed.

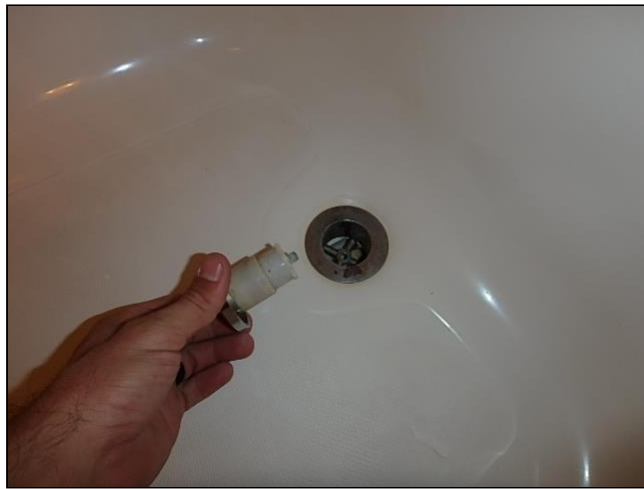
6.0 Picture 2

6.0 (4) The stop valves were damaged and/or missing at both the upstairs master bathtubs. The tubs are unable to hold water as a result. Recommend that a qualified plumber or person repair or install stop valves as needed and per standard building practices.

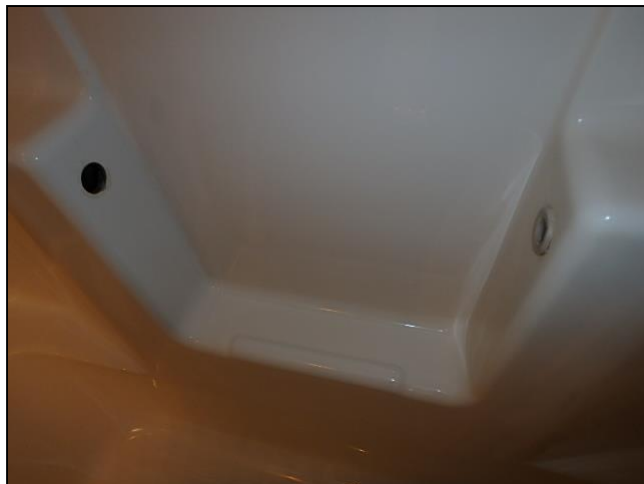
6.1 Picture 1

6.1 (2) The towel bar was missing at the upstairs master bathtub (on right). This can result in water penetration behind the tub, resulting in damage to the wall and floor framing components. Recommend that a qualified contractor or person install towel bar per standard building practices.

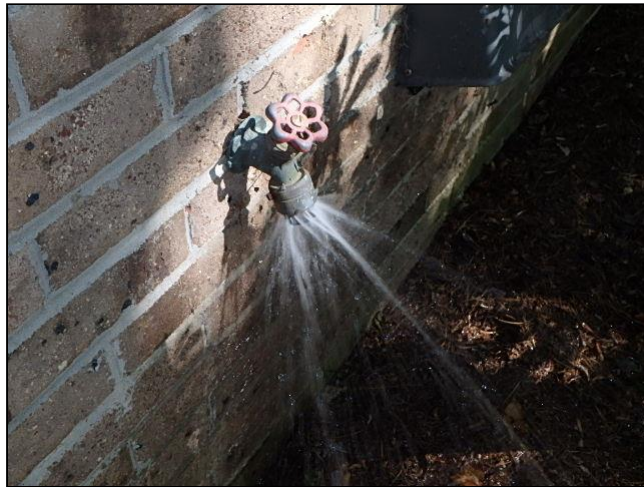
6.1 Picture 2

6.1 (3) The vacuum breakers for the exterior hose faucets were missing and/or leaking when the faucet was turned on. Vacuum breakers are designed to prevent water in the hose from moving back into the water supply if the water pressure in the home was to drop. Recommend that a qualified plumber repair or install vacuum breakers as needed and per standard building practices.

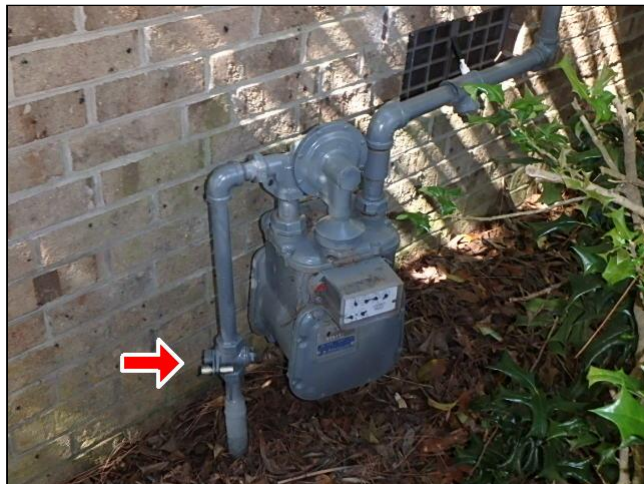
6.4 Picture 1

6.4 Note: The gas service was locked off at the time of inspection. We did not inspect for leaks.

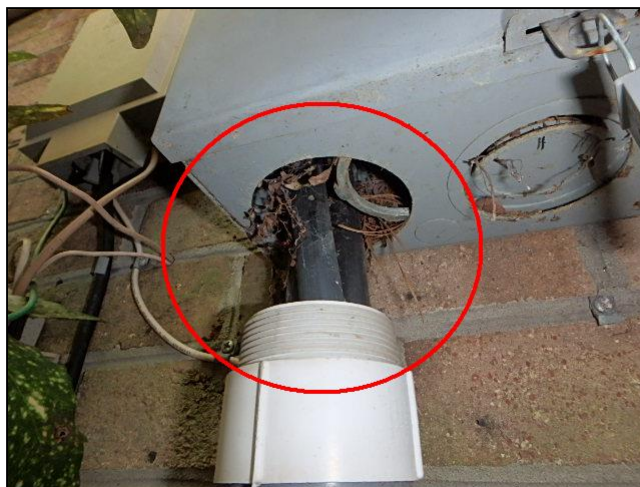
7.0 Picture 1

**7.0 The Service Entrance**

Conductors were exposed where they entered the electrical meter box. Service Entrance Conductors are required to be placed inside piping for protection. Recommend that a qualified electrician repair per standard building practices.

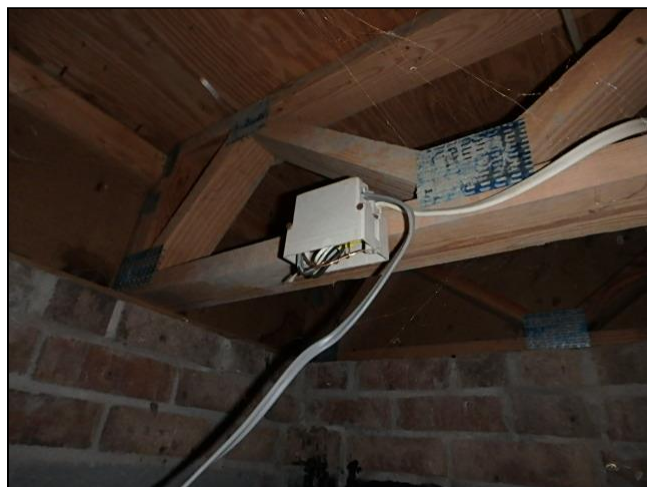
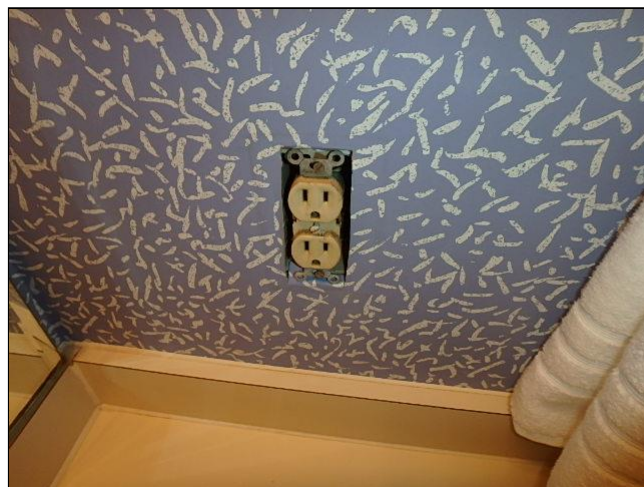
7.2 (2) Cover plates for receptacle (outlet) in the upstairs master bath (on left) and junction box in the crawlspace were missing. These plates are intended to contain fire and prevent electric shock from occurring due to exposed wires. Recommend that a qualified person install cover plates.

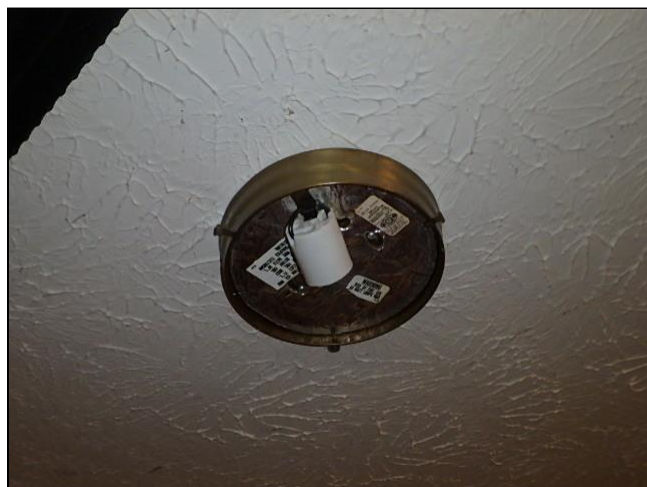
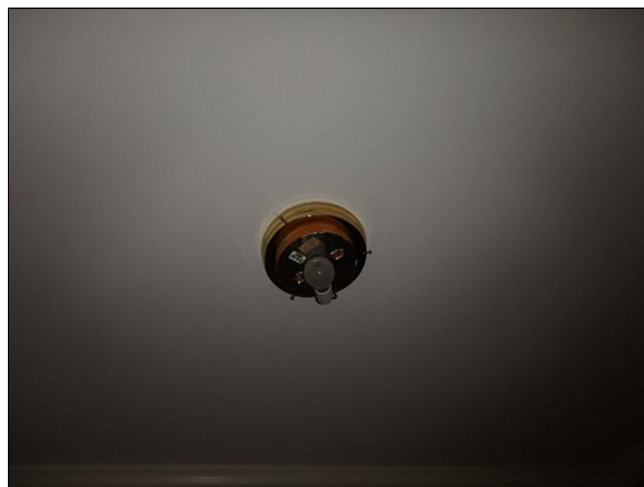
7.3 (2) Note: Covers for one or more light fixtures were missing. Recommend installing as necessary to avoid exposed bulbs.

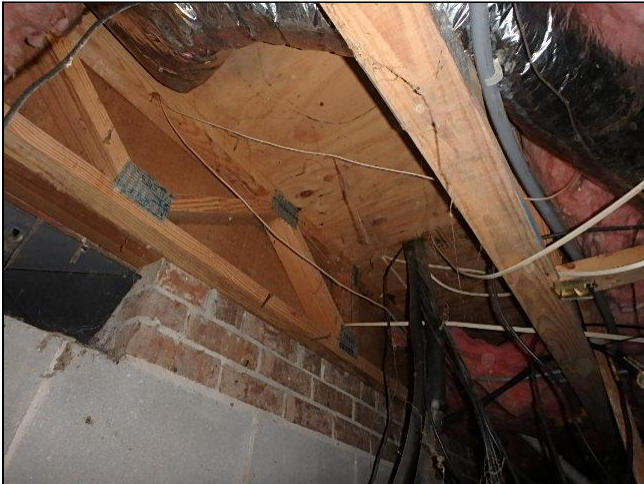
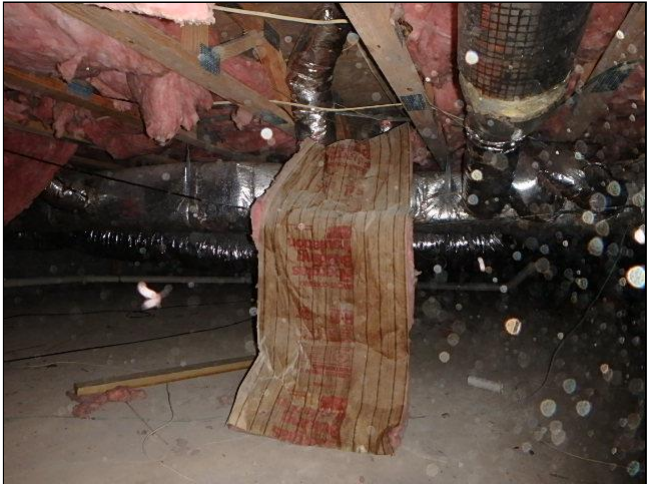
9.1 The subfloor insulation has come loose and/or is missing at various areas throughout the crawl space. This will cause unnecessary heat loss in winter and heat gain in summer, and increase energy costs for the property. Recommend that a qualified contractor or person repair or correct as needed and per standard building practices.

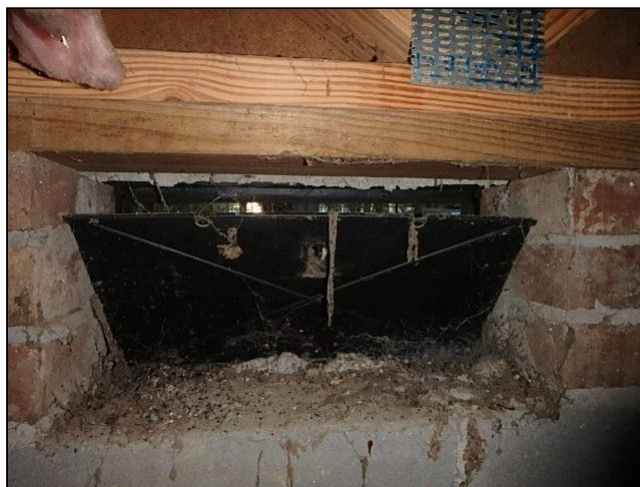
9.3 Picture 1

9.3 (1) One or more of the crawlspace vent doors were disconnected from their hinges and could not be opened. This restricts ventilation in the crawl space and can result in increased levels of moisture inside. Recommend that a qualified person repair as needed.

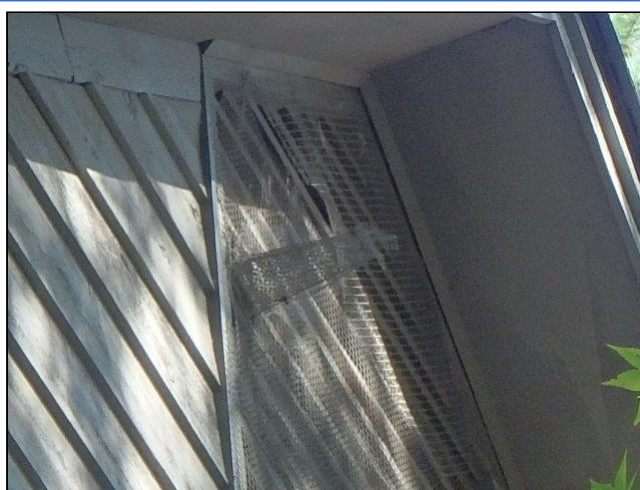
9.3 Picture 2

9.3 (2) The gable vent screen at the front of home was damaged. Recommend that a qualified contractor or person repair or replace screen as needed to prevent intrusion of birds and any other type of vermin.

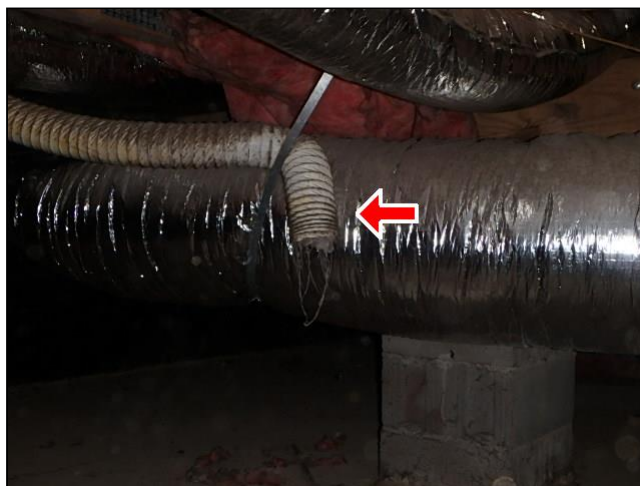
9.4 Picture 1

9.4 (1) The clothes dryer exhaust duct was terminating in the crawl space. Clothes dryers produce large amounts of moisture which should not enter structure interiors. Moisture can accumulate and result in mold, bacteria or fungal growth. Recommend that a qualified contractor or person repair per standard building practices.

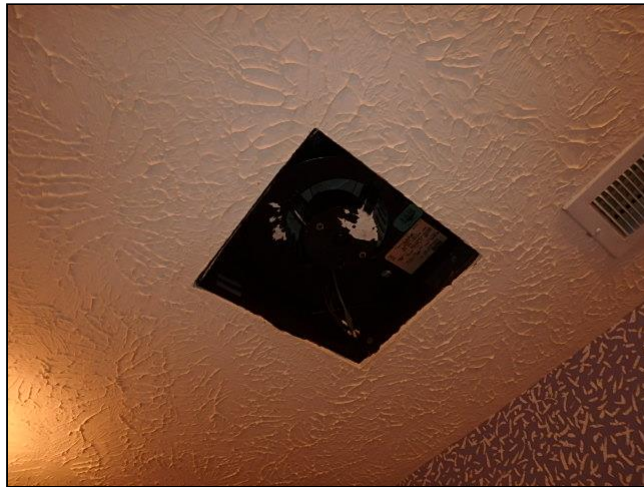
9.4 Picture 2

9.4 (2) The exhaust fan in the upstairs master bath (on left) did not function when tested and was missing its cover. Moisture can accumulate and result in mold, bacteria or fungal growth. Recommend that a qualified contractor repair or replace as needed.
